DEPARTMENT OF TRANSPORTATION**DIVISION OF ENGINEERING SERVICES**

Quality Assurance and Source Inspection

Contract #: 04-0120F4Cty: SF/Ala Rte: 80 PM: 13.2/13.9File #: 69.28**WELDING INSPECTION REPORT****Resident Engineer:** Pursell, Gary**Address:** 333 Burma Road**City:** Oakland, CA 94607**Report No:** WIR-012761**Date Inspected:** 20-Mar-2010**Project Name:** SAS Superstructure**OSM Arrival Time:** 1900**Prime Contractor:** American Bridge/Fluor Enterprises, a JV**OSM Departure Time:** 700**Contractor:** Zhenhua Port Machinery Company, Ltd (ZPMC), Changxing Island **Location:** Shanghai, China**CWI Name:** See below**CWI Present:** Yes No**Inspected CWI report:** Yes No N/A**Rod Oven in Use:** Yes No N/A**Electrode to specification:** Yes No N/A**Weld Procedures Followed:** Yes No N/A**Qualified Welders:** Yes No N/A**Verified Joint Fit-up:** Yes No N/A**Approved Drawings:** Yes No N/A**Approved WPS:** Yes No N/A**Delayed / Cancelled:** Yes No N/A**Bridge No:** 34-0006**Component:** Tower and OBG Components**Summary of Items Observed:**

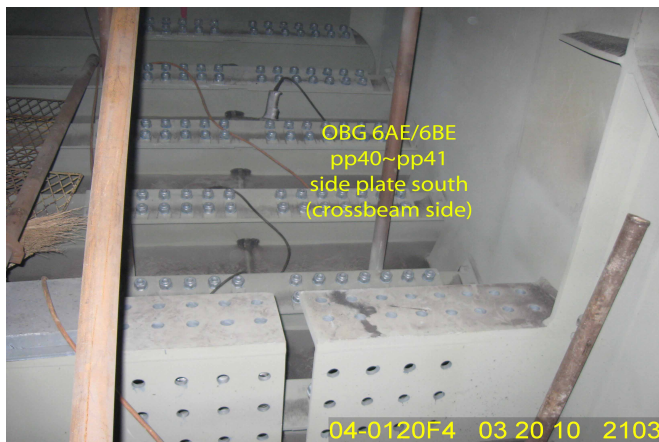
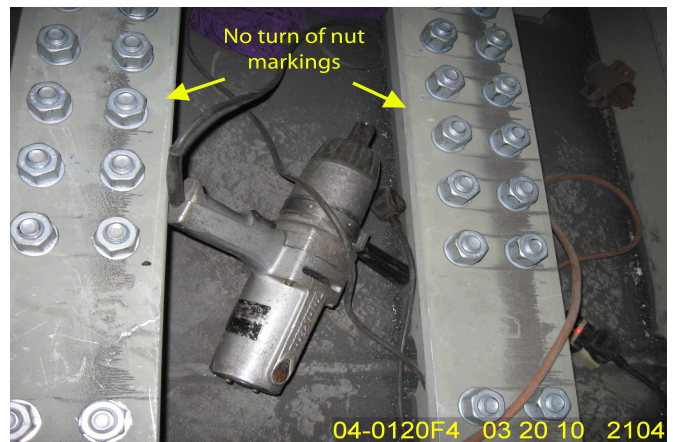
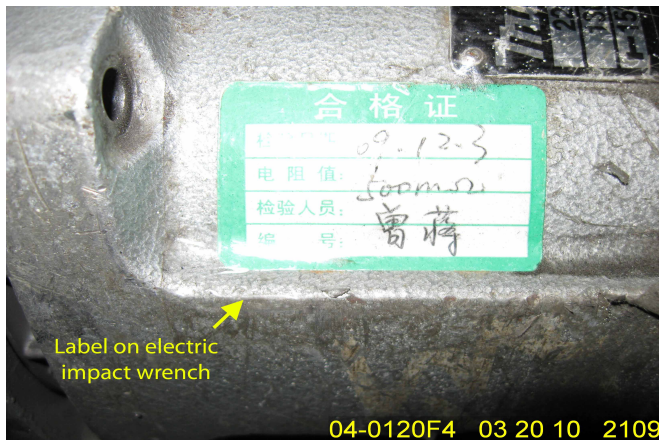
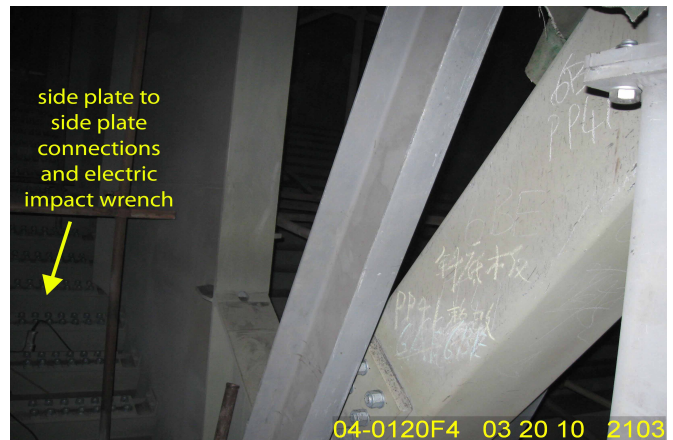
OBG segment 6E was located near the end of the heavy dock. ZPMC workers were performing what appeared to be snug tightening using hand wrenches at the bottom plate in the FL3 area of segment 6BE near the interface with CB5. ZPMC workers were inside 6BE near the west side of panel point 41, using an electric impact wrench tightening bolt sets on the side plate to side plate connections. The bolt sets were observed to be not yet marked for turn of the nut verification. ZPMC Bolting Crew Foreman Rao Hai Chow informed this QA Inspector that the workers were using the impact wrench in a limited tightening manner so as to achieve a snug tight level only and that ABF Representative David Woo and Caltrans Structural Materials Representative Aaron Prchlik had observed the snug tightening with the electric impact wrench and approved the procedure. The electric impact wrench appeared to be rated at 500 NM. See photos below.
